Matthew Alkins
Date : 13.10.2026

Customer: Corey Besner
Vehicle: Landrover Defender Puma 90 2008

Repairs and modifications carried out since October 2023

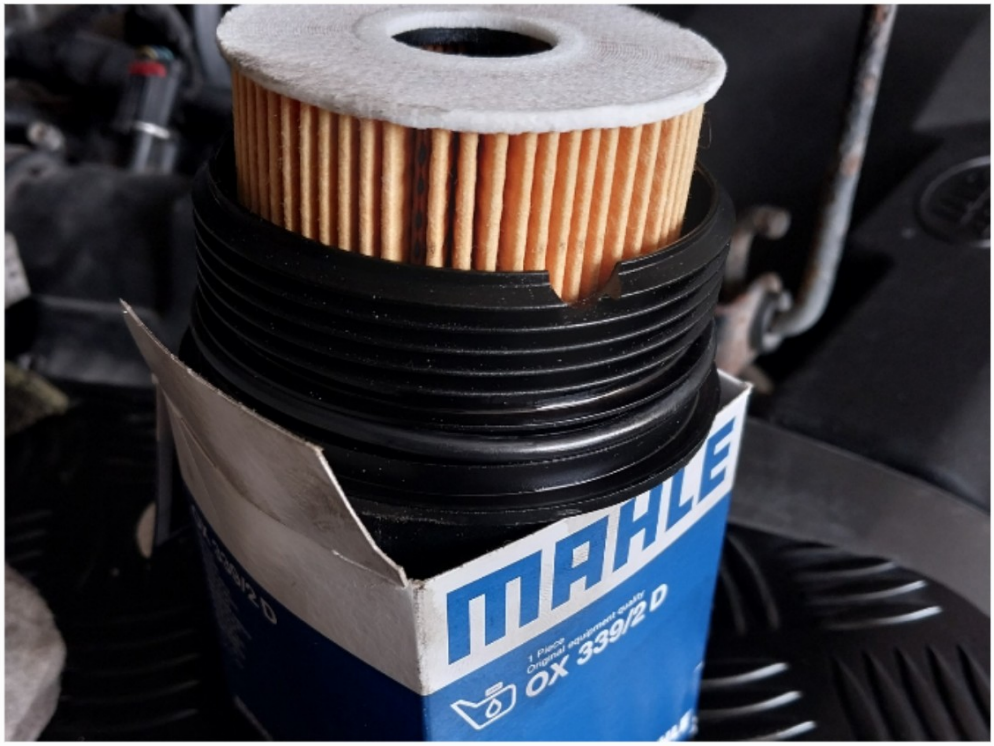
MAHLE
1 Piece
Original equipment quality
OX 339/2 D

Synthesis
F
5W-30
5W-30
ROCK OIL
1L

DENSO
Made in China
